# Team Product Document

GO Number 97055	S/A Number 32120	Page 1 of 59	Total Pages 59	Rev. Ltr/Chg. No. See Summary of Chg. New	Number EID-08640
Program Title Closure of ETEC (R21-RF)					
Document Title Building 4059 (SGPTF) Decontamination and Decommissioning Final Report					
Document Type Engineering Information Document			Related Documents		
Original Issue Date 05-02-2005		Release Date <b>RELEASE</b> 05-02-05 CV		Approvals Date	
Prepared By/Date R. D. Meyer D. M. Trippeda		Dept. 694 117	Mail/Addr T038 T038	B. D. Sujata	
IR&D Program? Yes <input type="checkbox"/> No <input checked="" type="checkbox"/> If Yes, Enter Authorization No.					
Distribution			Abstract

Building 059, designated as the SNAP Ground Prototype Test Facility (SGPTF) is one of a number of former nuclear test facilities that has been decontaminated and decommissioned at the Santa Susana Field Laboratory (SSFL). The SGPTF has been completely dismantled with all components and materials removed. This report documents the decontamination and dismantlement activities performed at the facility, which occurred over the time period of 1970 through 2004. Building 059 has more recently been referred to as Building 405

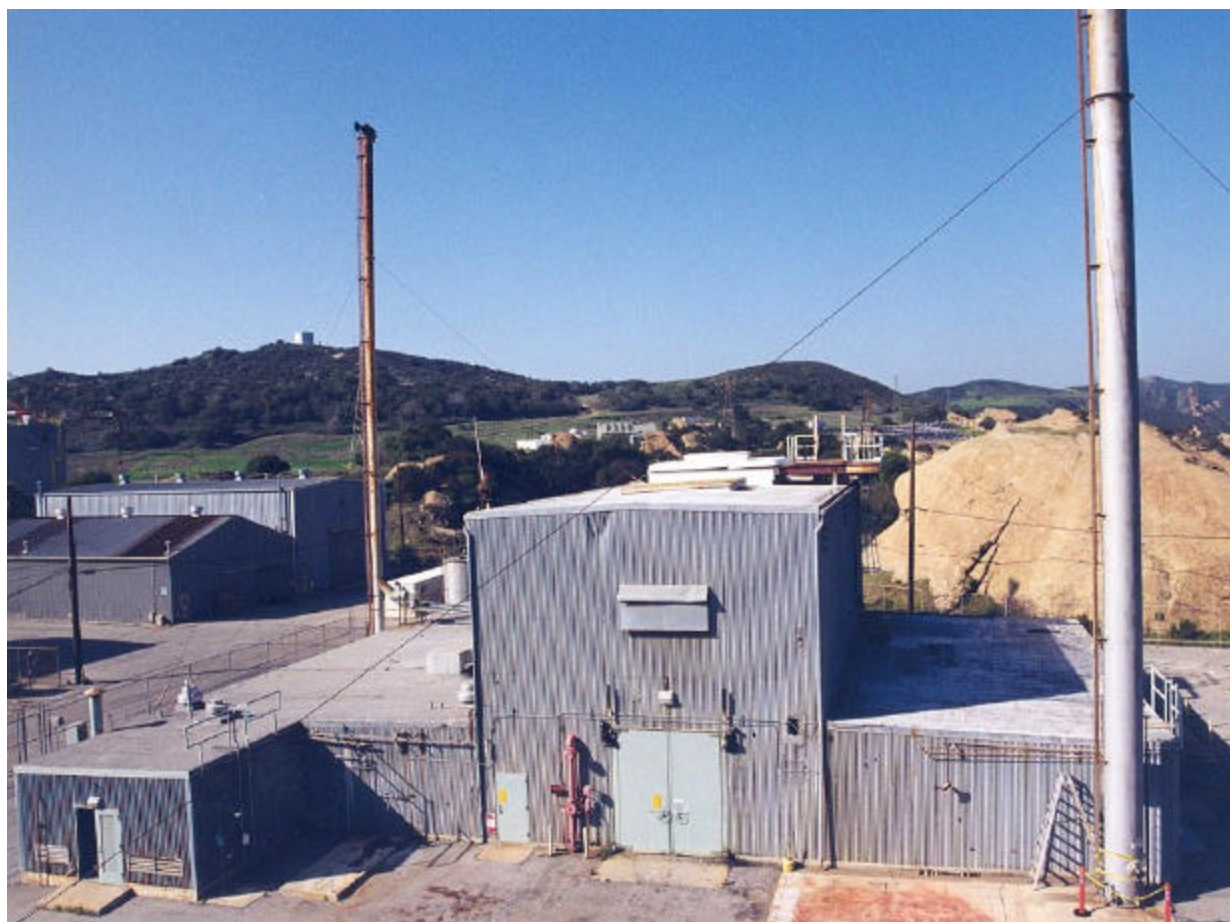
*Figure 1.3.1. Photograph (facing west) of Above Grade SGPTF in 1999*

The SGPTF was designed and constructed to test a SNAP nuclear reactor and modified shortly after initial construction was completed. The facility featured an underground “shielded controlled atmosphere vault” and included the following access areas: a high bay vault access and secondary equipment area, a general support and operating area, mechanical and electrical support area, a pump room and a vacuum equipment room. The high bay area was flanked by two attached low bay structures containing the control room and office area on the south and electrical, mechanical equipment and support areas on the north. A photo showing the above grade structure from the east is shown in Figure 1.3.1.

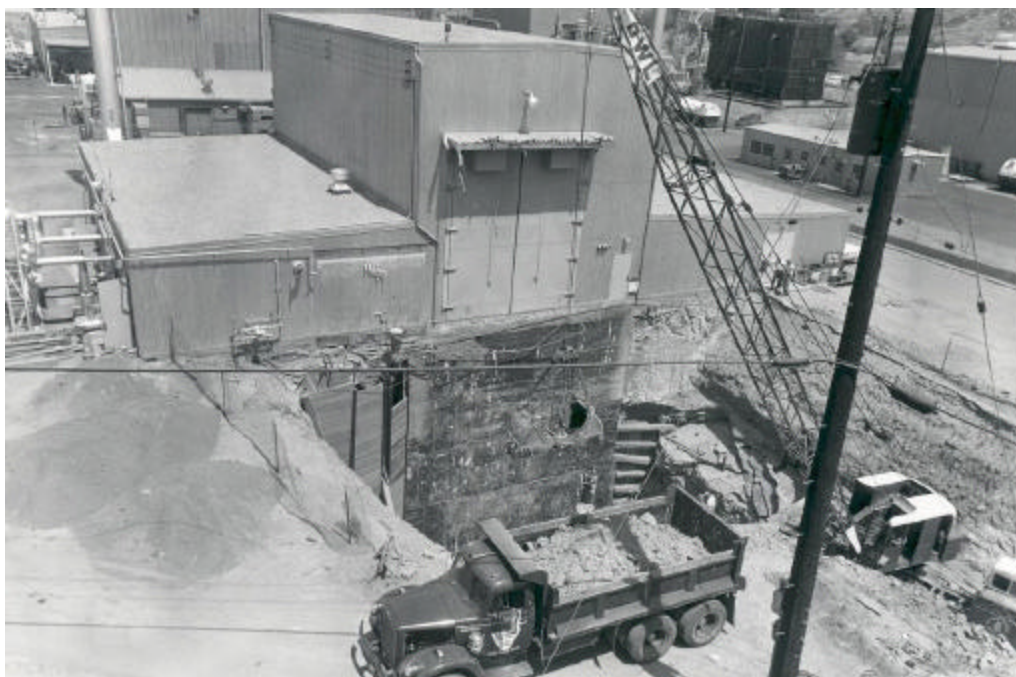
*Figure 1.3.2. Excavation for the West Addition in 1964*

Construction of Building 059 started in July 1961 and was completed in May, 1963. During 1964 and 1965, the building was modified to rebuild the north test cell and to construct an underground concrete addition attached to the original building structure. Figures 1.3.2 and 1.3.3 present photos taken during construction of the addition in 1964. The final configuration of the building is represented in the conceptual drawing Figure 1.3.4. Plan and elevation views of the test vault, test cells, and the west addition are shown in Figures 1.3.5 and 1.3.6, respectively. The addition floors, ceilings and the three outside walls are formed of 2-foot thick steel-reinforced ordinary concrete. The fourth, inside (east) wall consisted of the 3-1/2 foot thick original building west wall. The addition was constructed to house a larger vacuum system for improved simulation of space environment in the test cell.

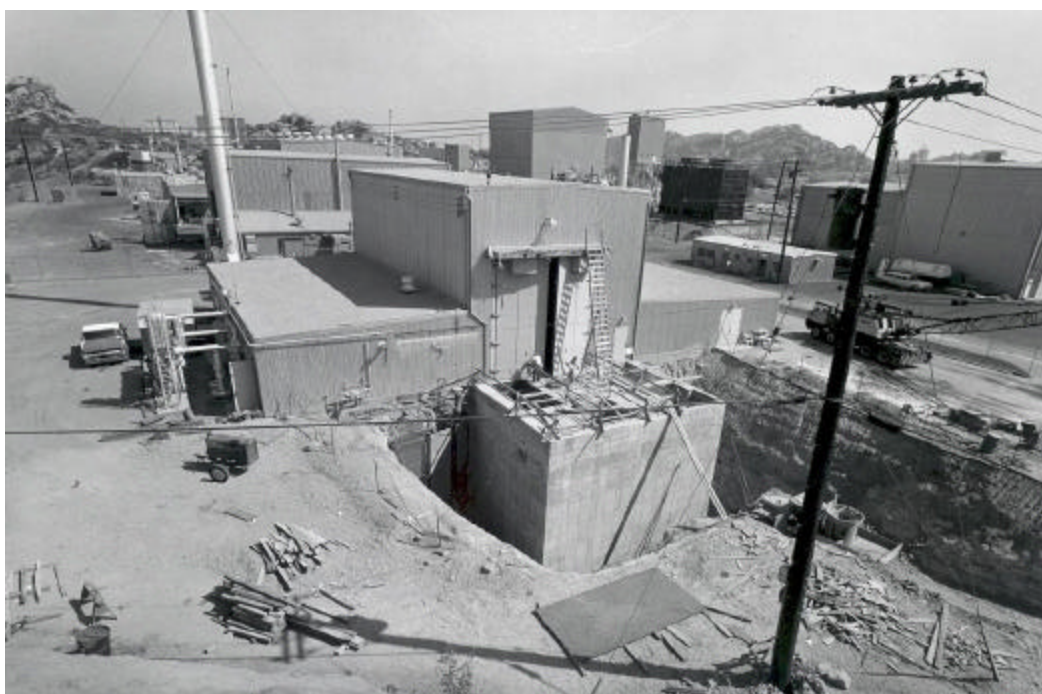
*Figure 1.3.3. West Addition Concrete Near Completion in 1964*

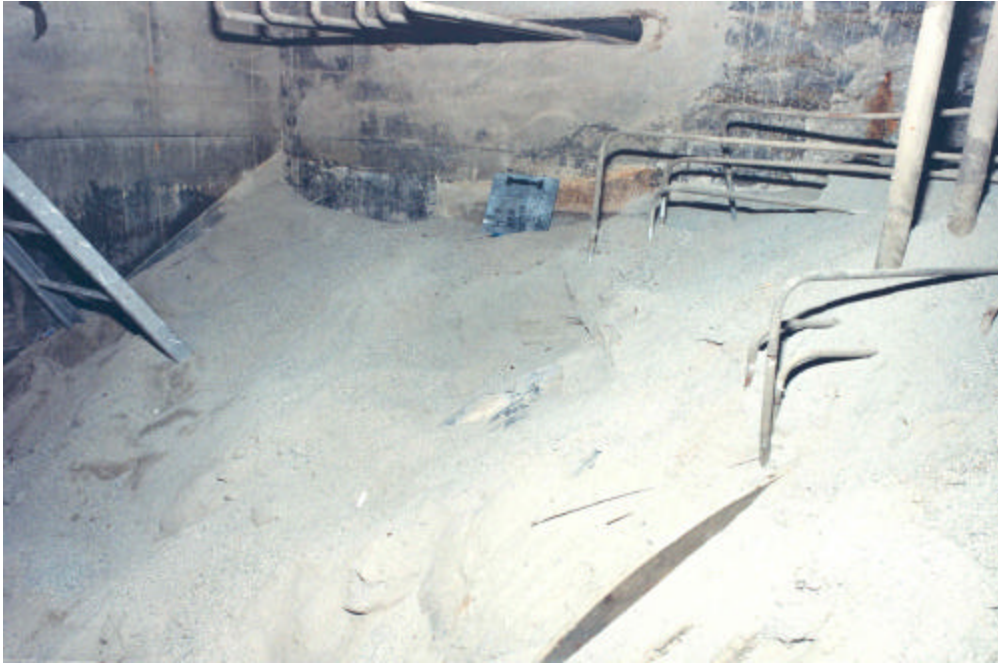
*Figure 2.3.2. View of PCR Looking East at Test Cell Location*

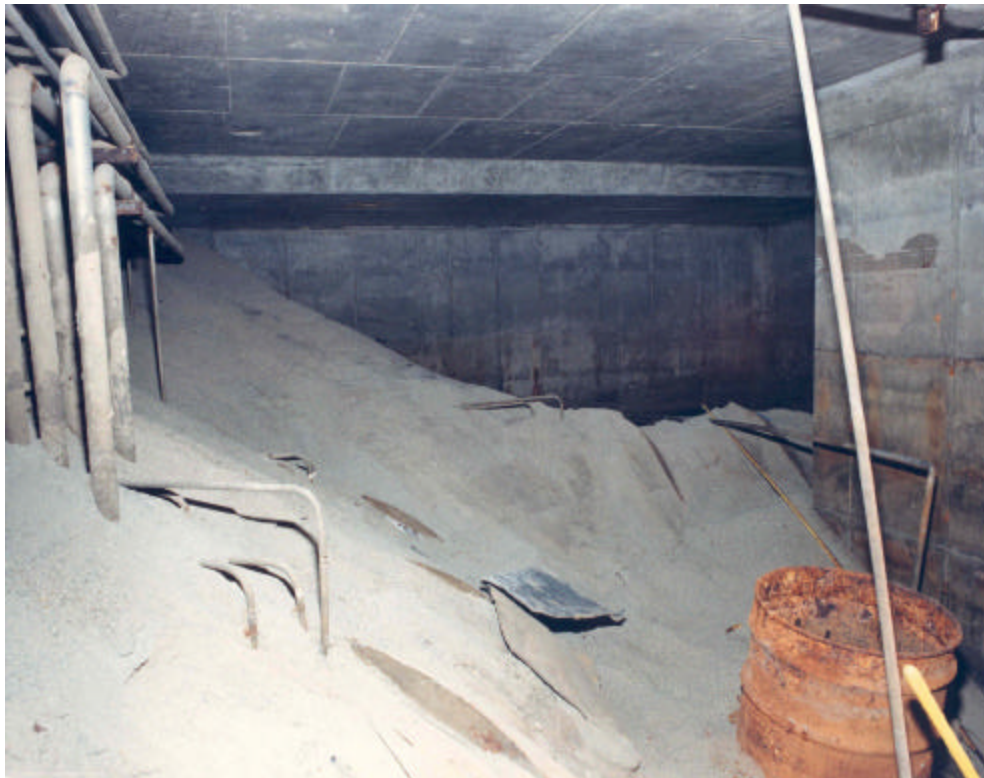
*Figure 2.3.3. View of PCR Looking South  
(Note drum and lead shielding from 1978 D&D operations)*

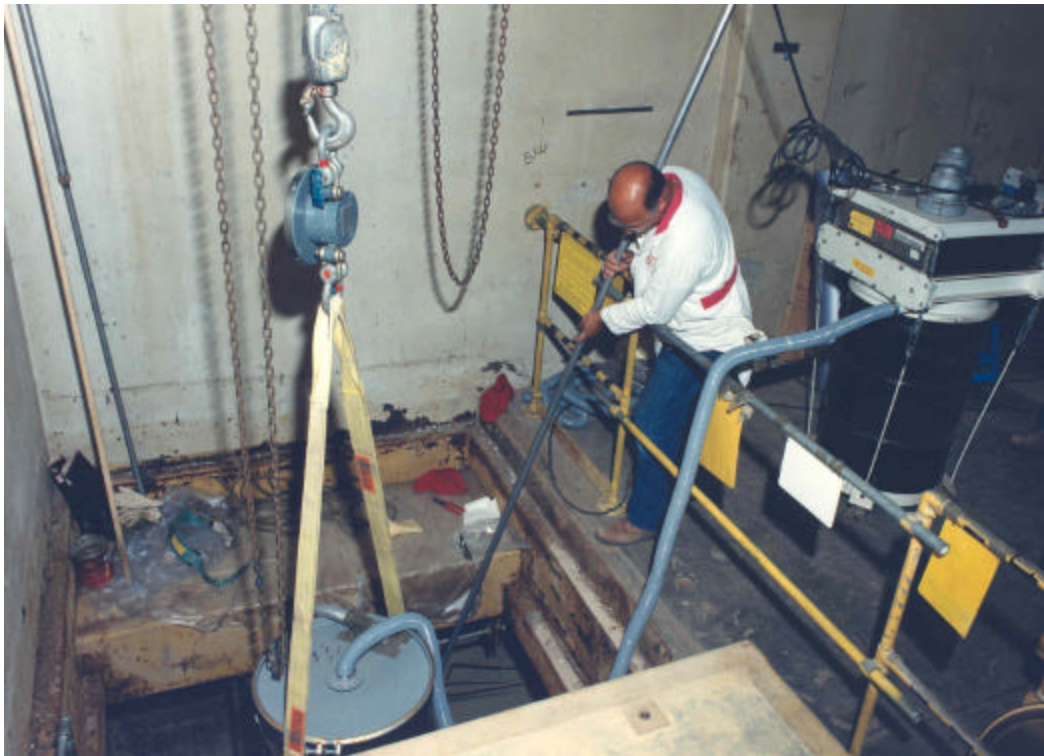
*Figure 2.3.4 Worker Using Pole to Guide Vacuum Pickup*

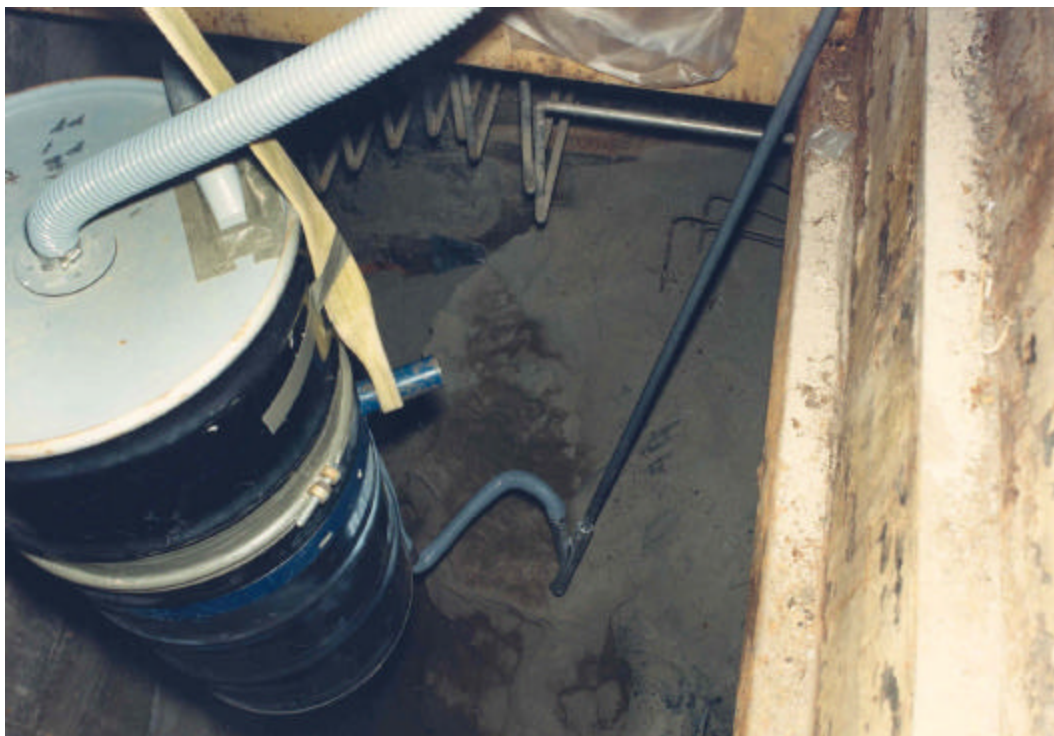
*Figure 2.3.5 View of Vacuum Collection Drum and PCR Sand Below*

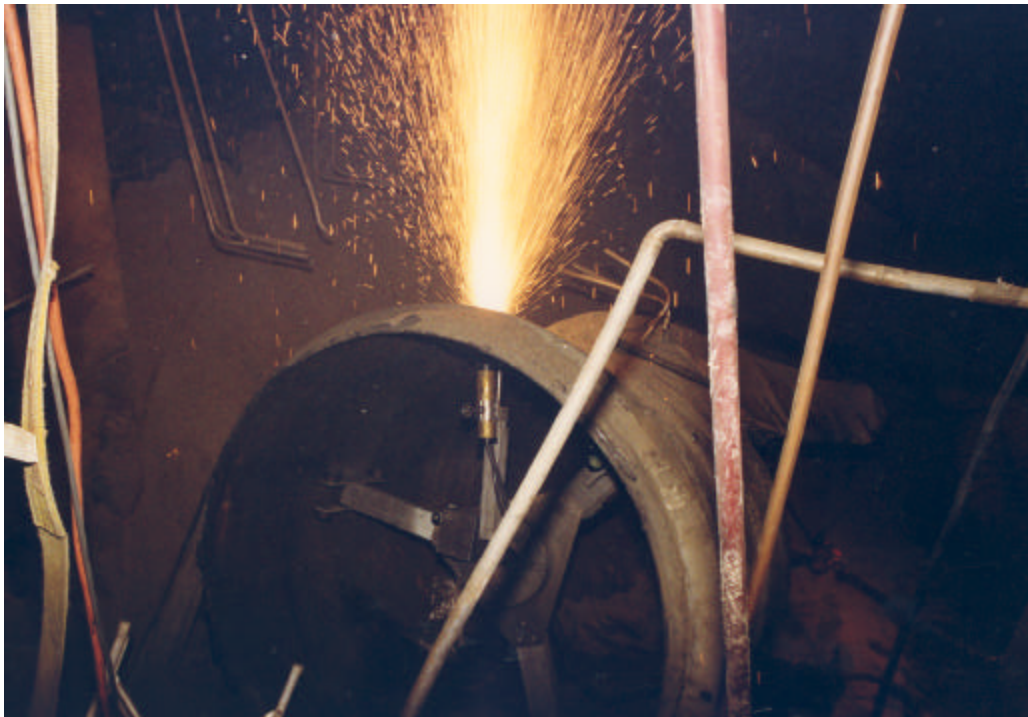
*Figure 2.3.7 Segmenting SS Duct with Remotely Operated Cutting Device*

cutting of the duct is illustrated in the mockup practice setup shown in Figure 2.3.6. Once enough sections of duct had been removed remotely, and the shielding block (Refer again to Figure 2.3.1) had been installed to reduce the exposure from the test cell components, personnel were able to enter the PCR to perform more efficient sand removal and to install and operate the remote cutting fixture to segment the remainder of the vacuum duct. Figures 2.3.7 and 2.3.8 illustrate the remote cutting device for the ducting.

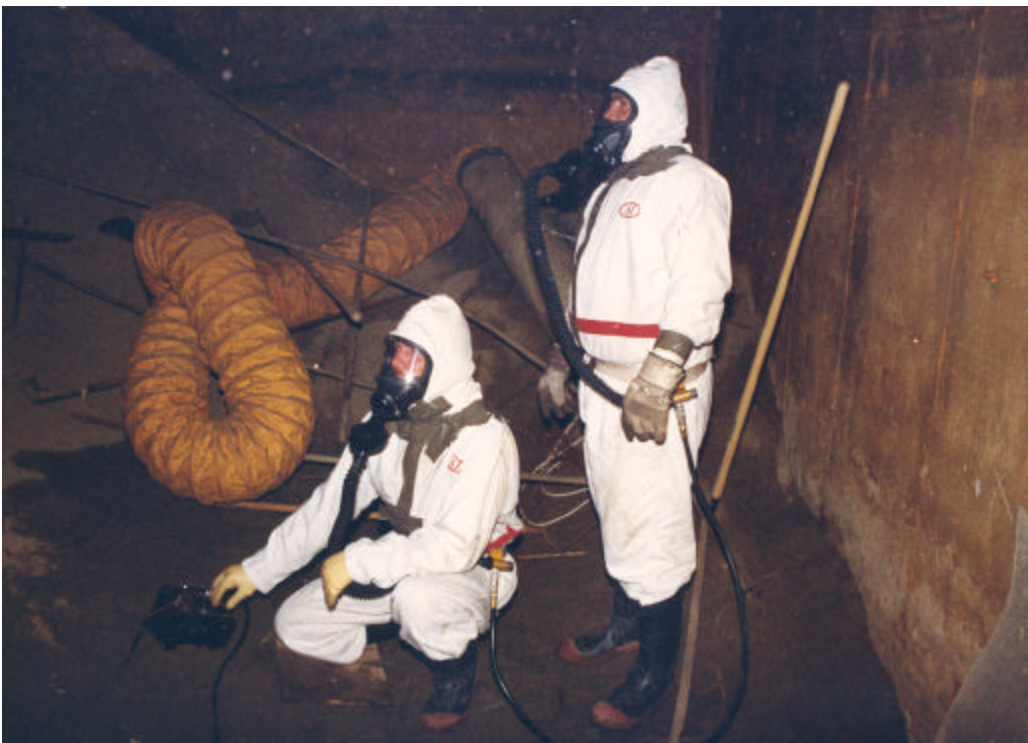
*Figure 2.3.8 Duct Cutting Device Operators Behind Shielding Wall in PCR*

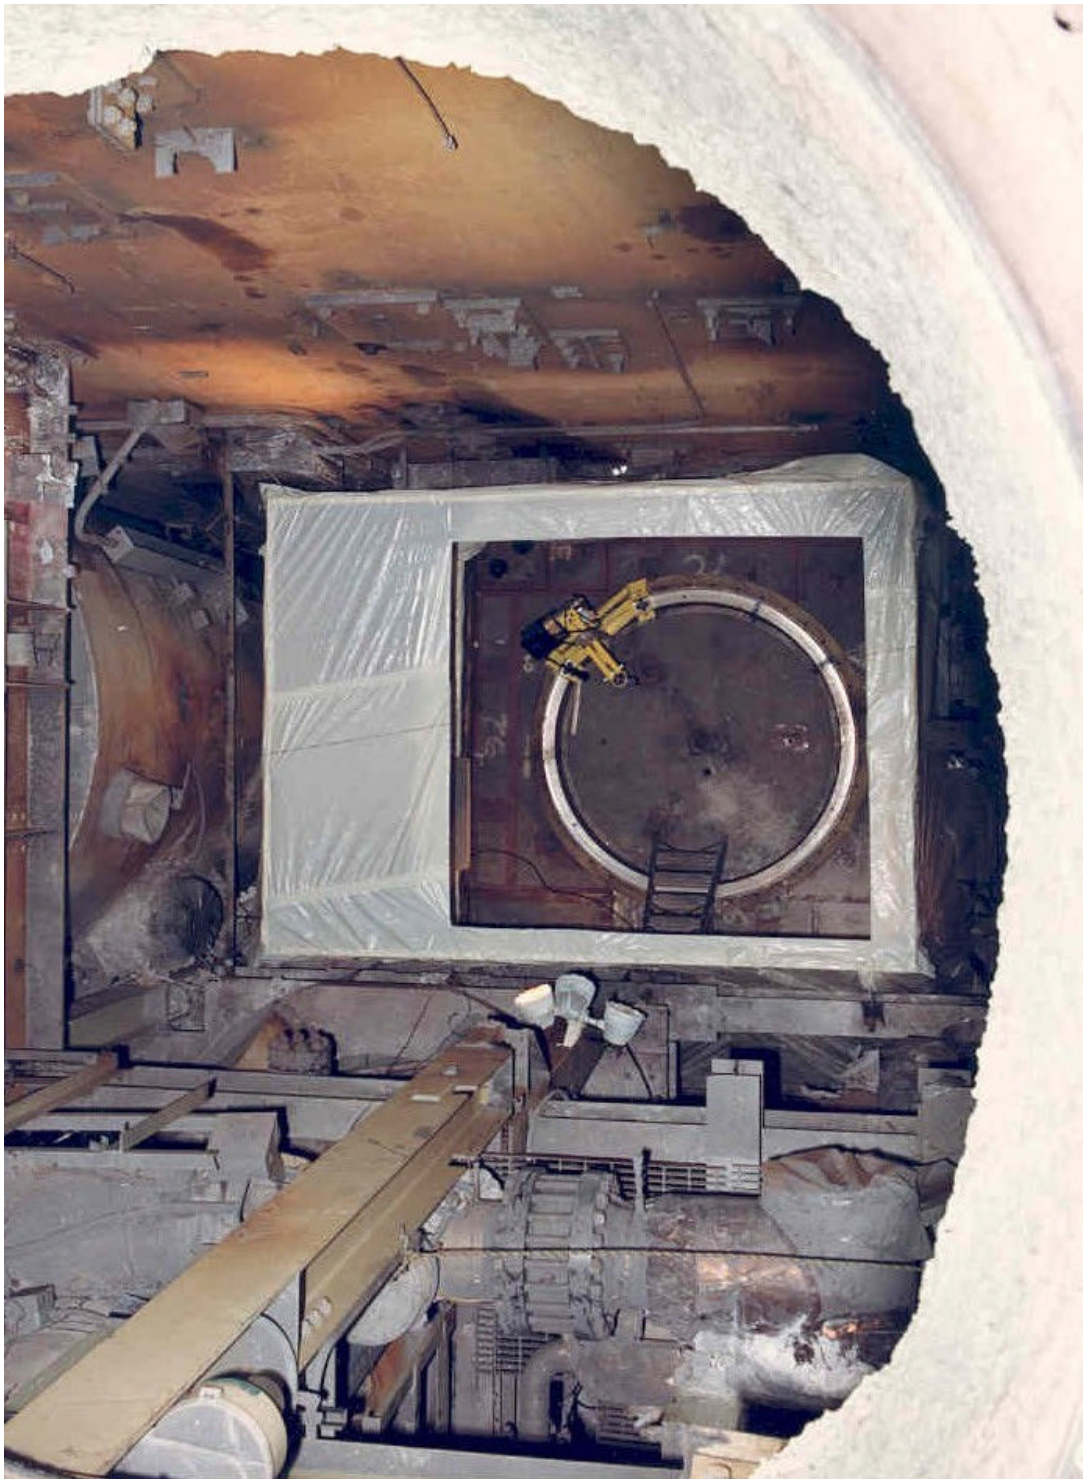
***Figure 2.4.2.2 View From Grade Level High Bay. LLTR Structure Removed To Allow Remote Cutting Equipment Access To Test Cell. Notice Containment Tent and Ring Mounted Hoist***

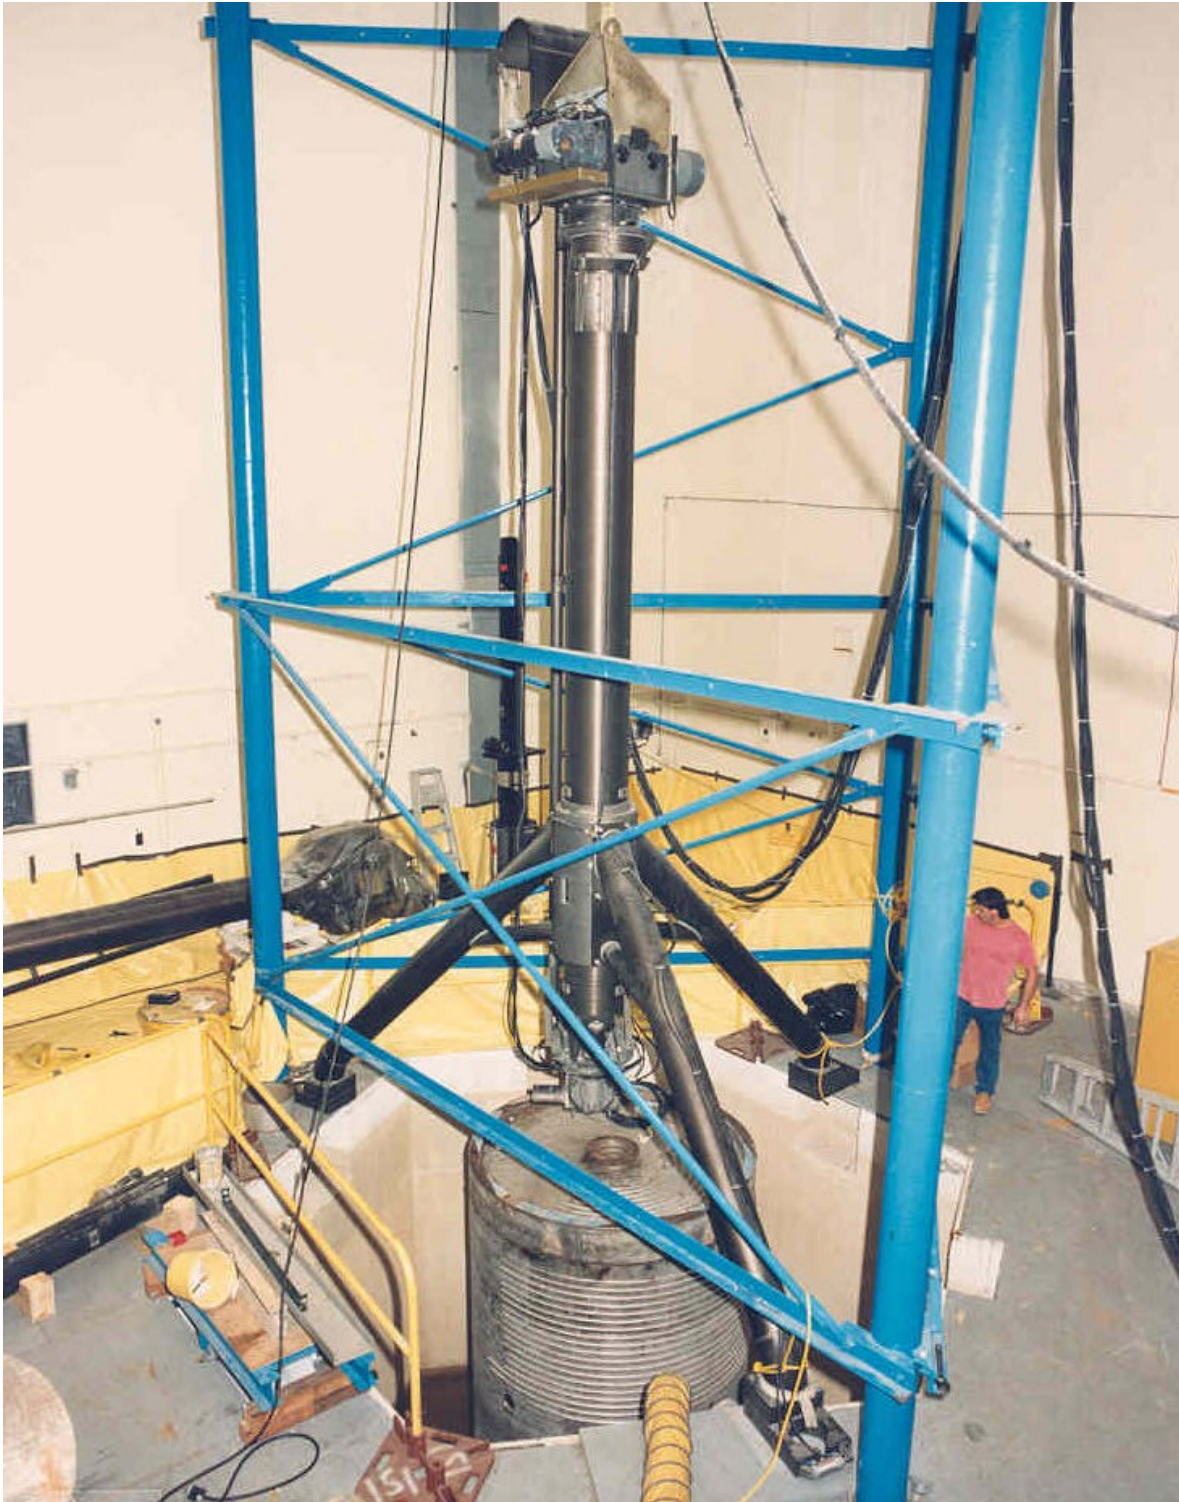
*Figure 2.4.2.3 Remote Cutting Equipment and Vessel Mockup*

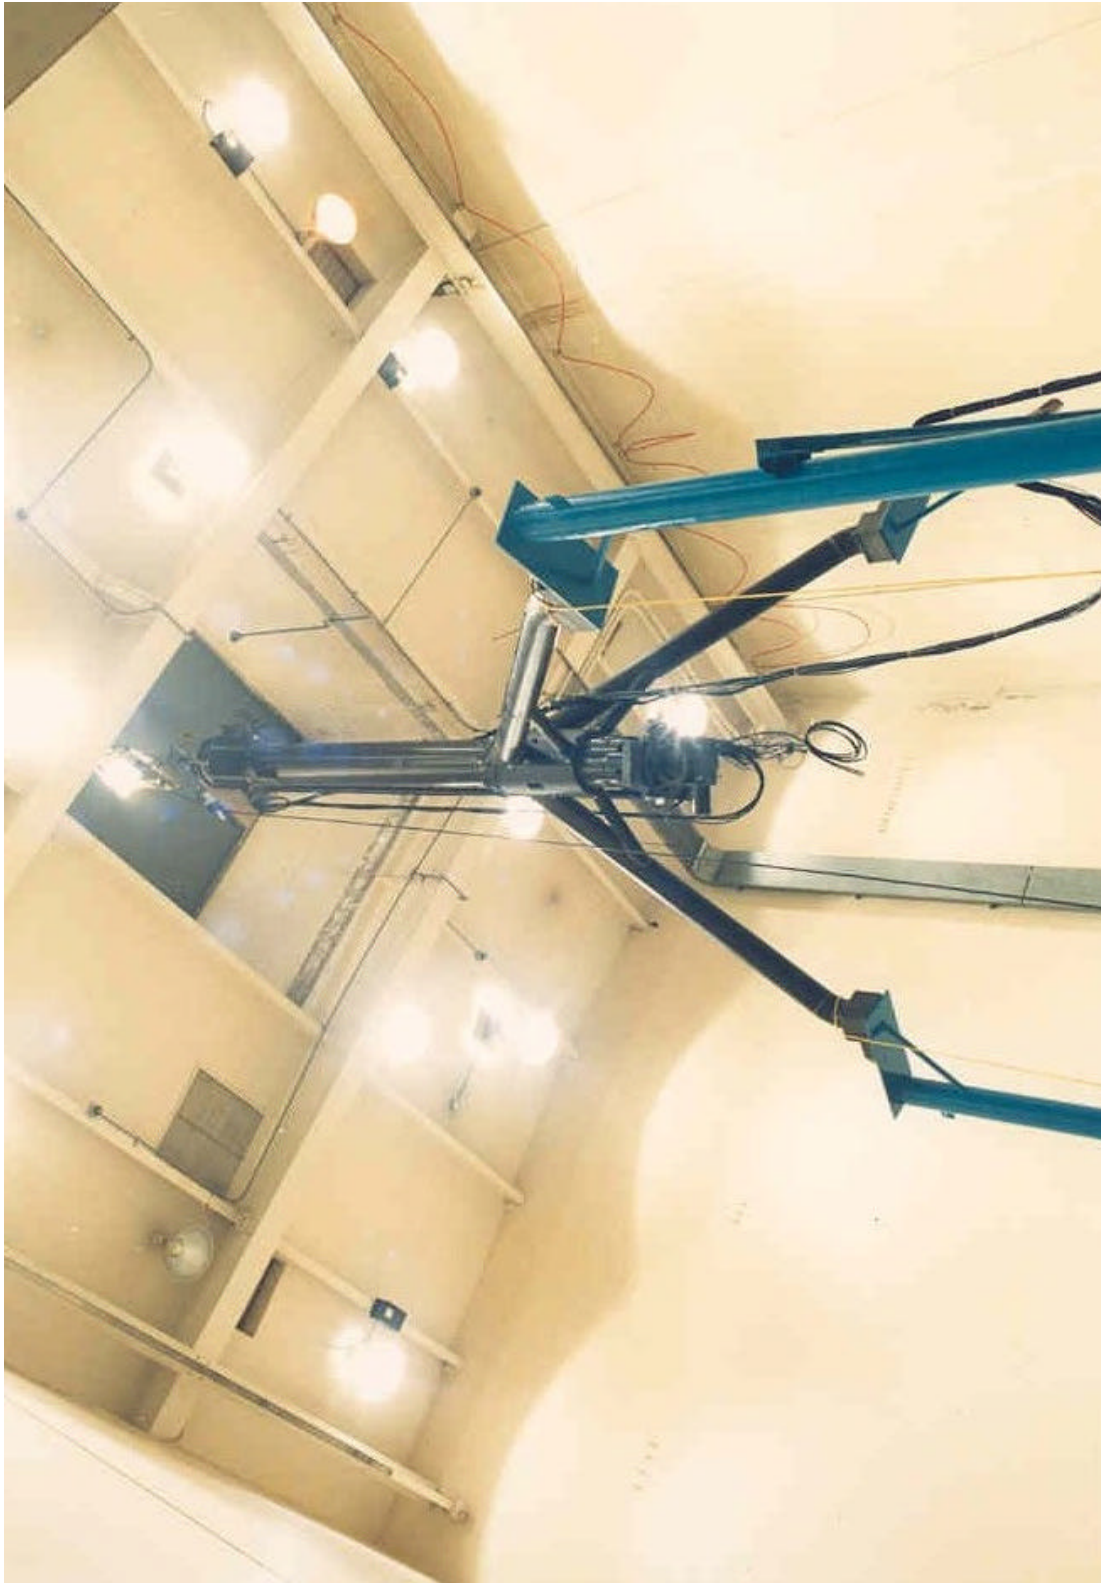
**Figure 2.4.2.4. Remote Cutting Device on Elevated Stand to Simulate Actual Elevations**

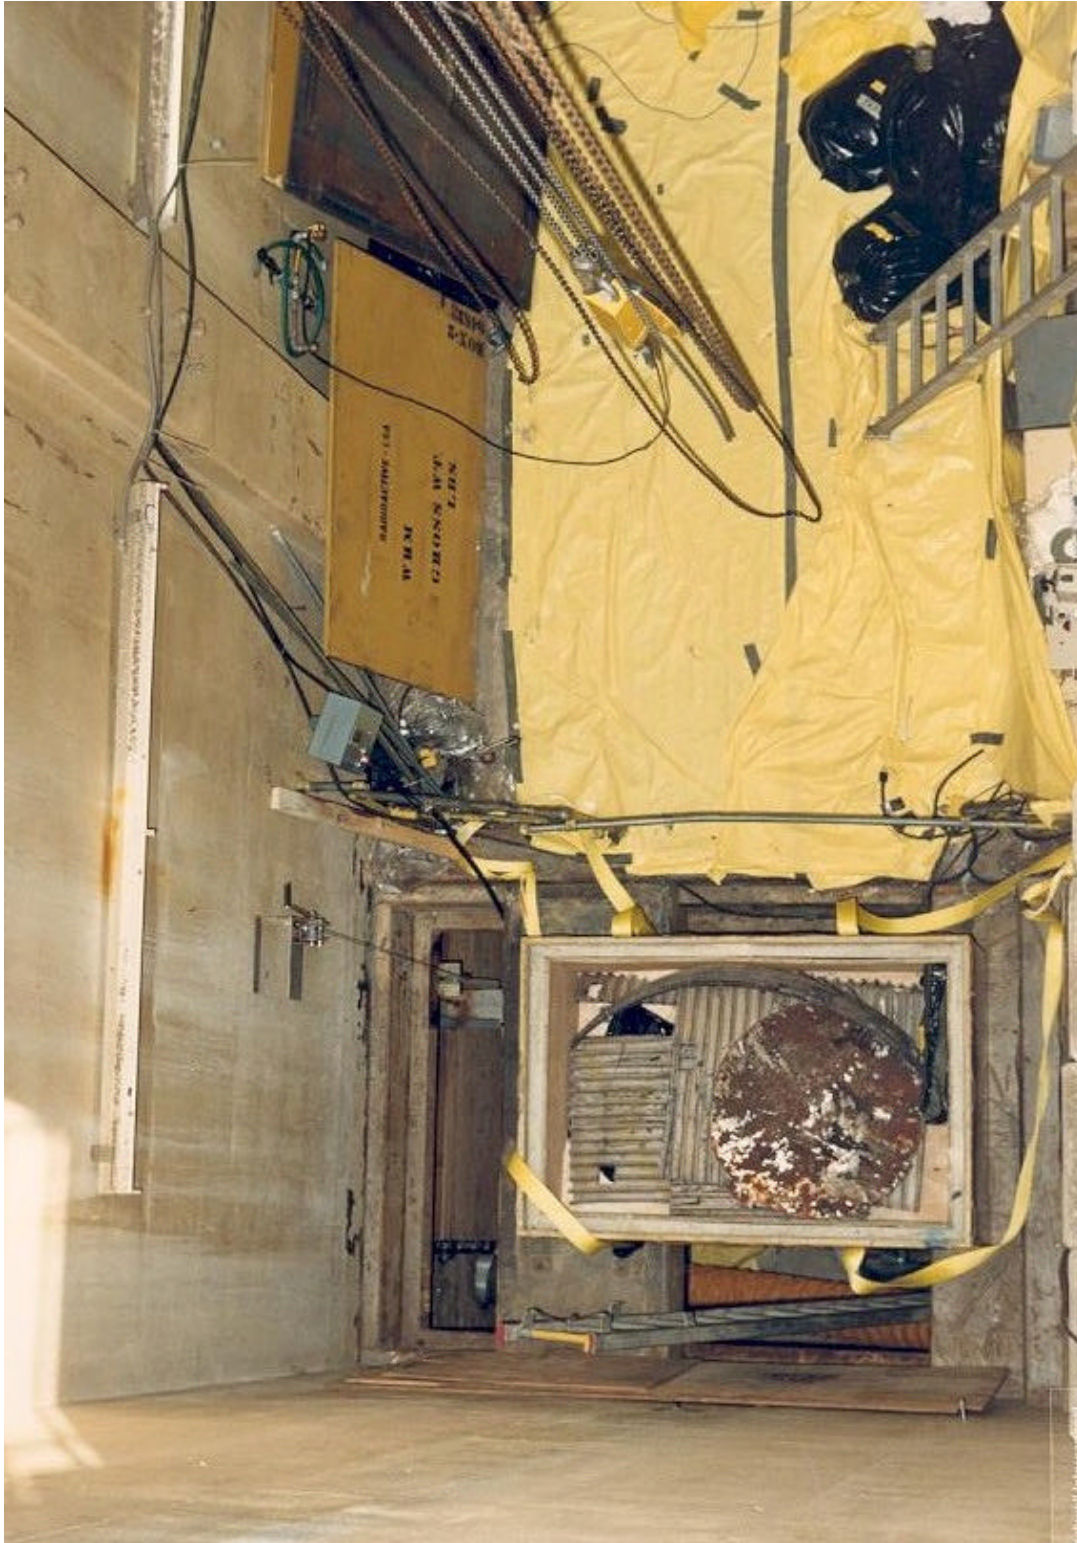
**Figure 2.4.2.5. View from Grade Level Looking at Vacuum Vessel Parts Loaded into Shielded Shipping Container. View is of Former Vacuum Equipment Room (Pipe Chase Room is below shipping container)**

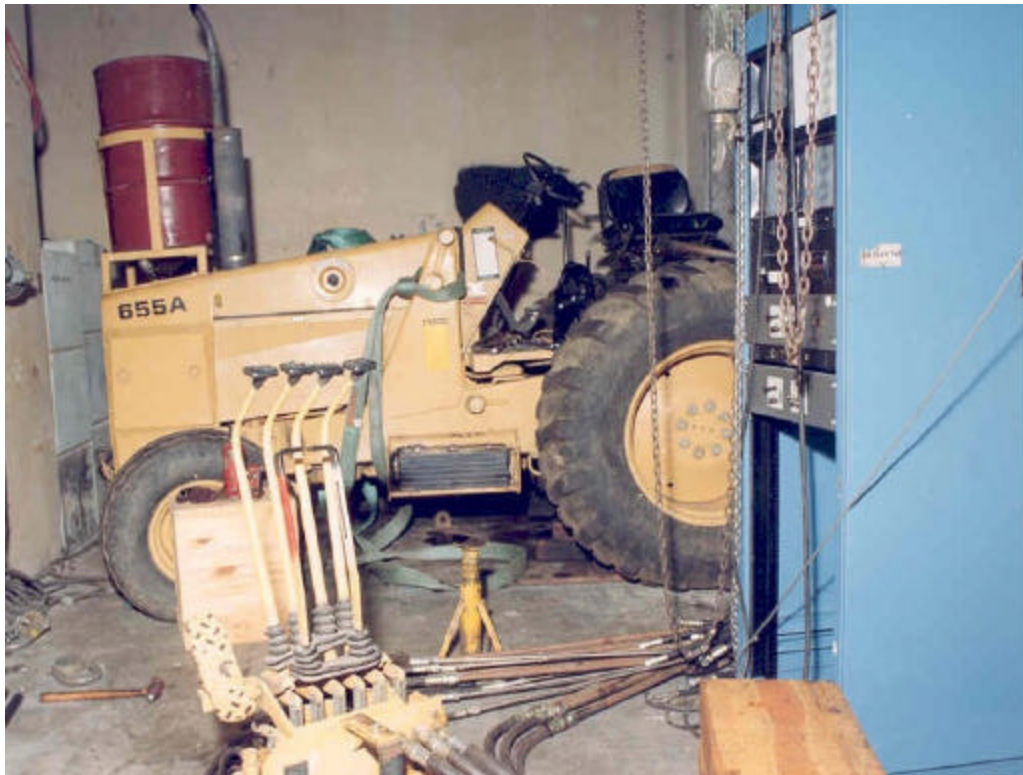
*Figure 2.4.3.3 Remote Operations Setup in the VER*

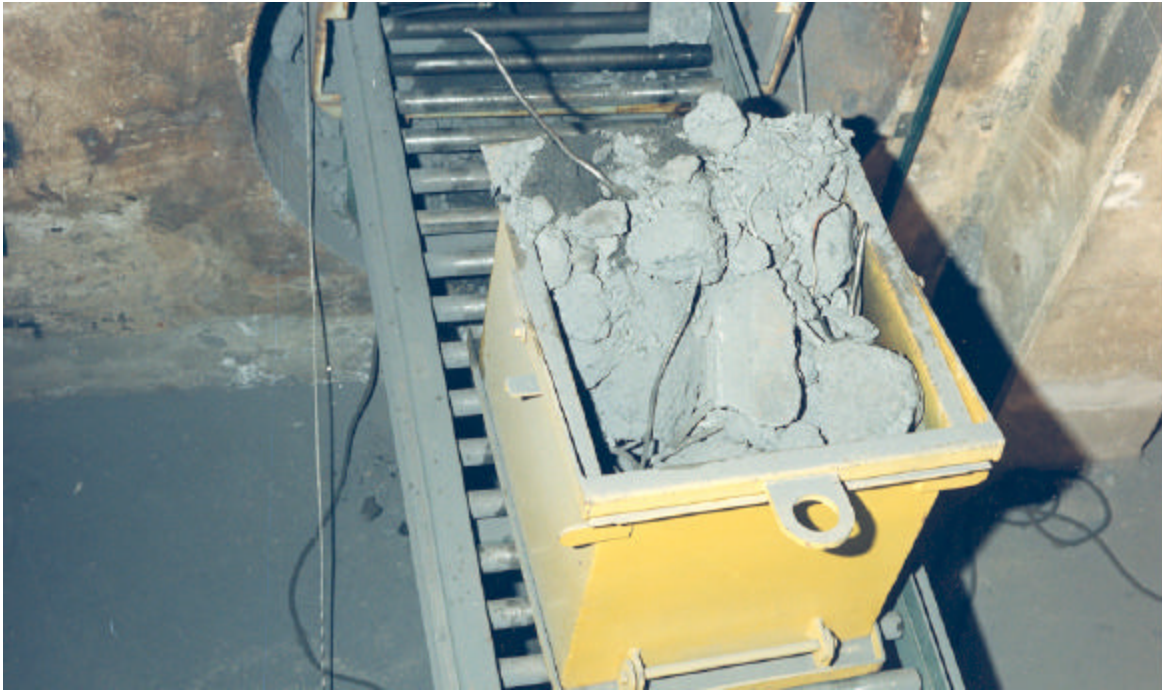
*Figure 2.4.3.4 Concrete Being Removed from the Test Cell Using the Conveyor*

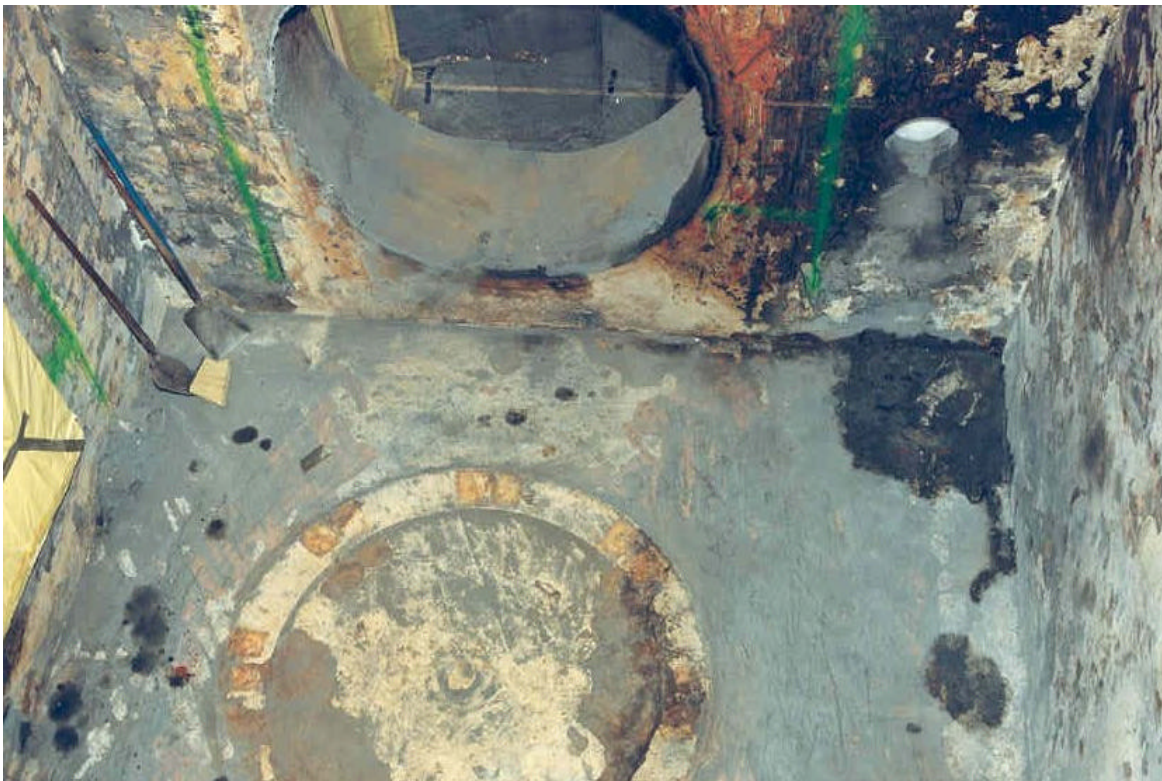
*Figure 2.4.3.5 North Test Cell Shielding Concrete Removed to the Cell Steel Liner*

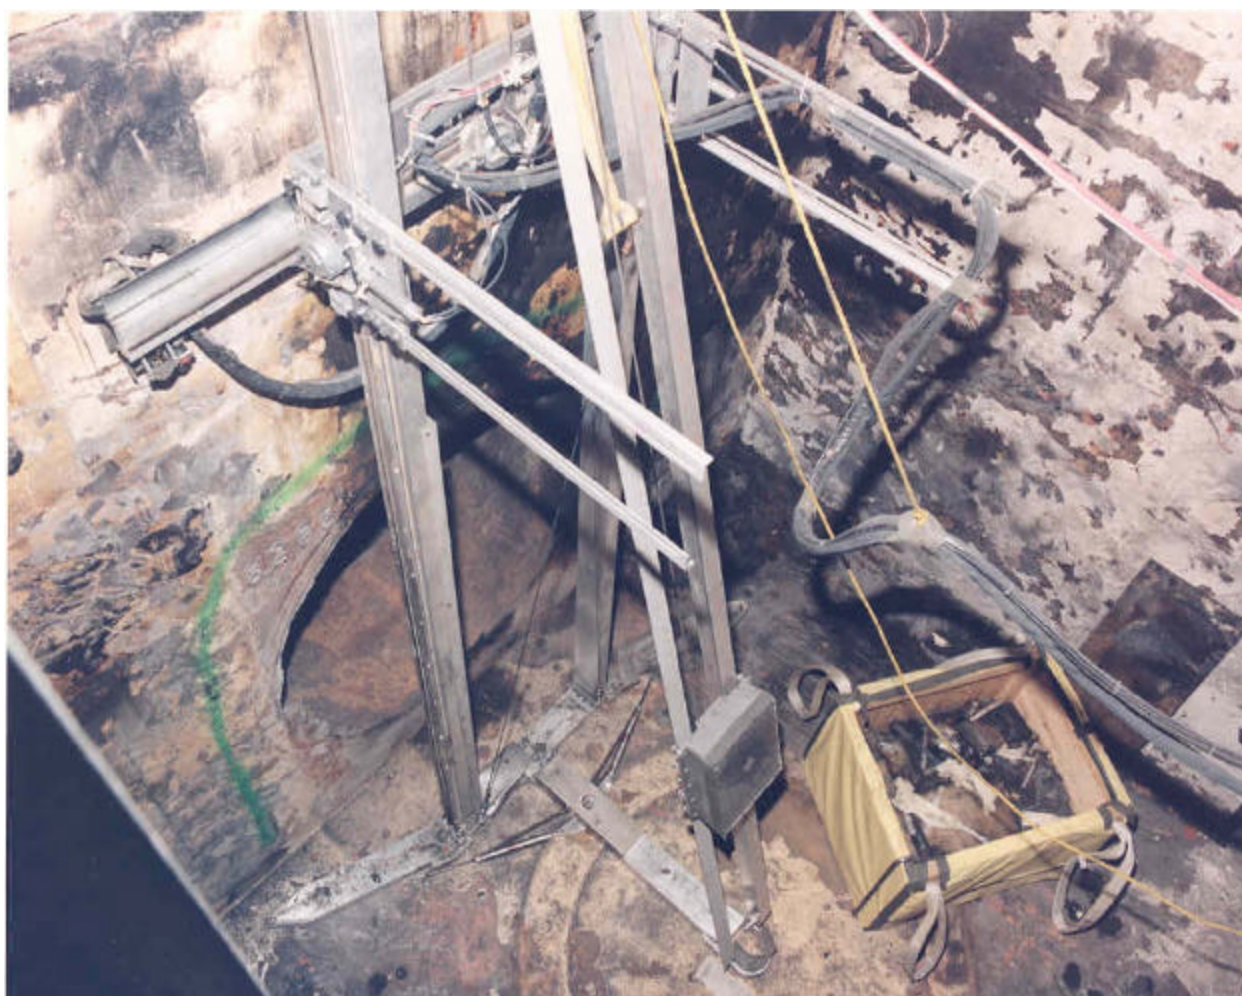
*Figure 2.4.4.1 North Test Cell Wall Liner Segmenting Device (WSD)*

Two special remotely controlled, plasma-arc torch metal-cutting devices were designed and assembled for the test cell lining removal task. These designs also utilized existing nuclear inspection and hot cell experience and technologies. The first device, the wall segmentation device (WSD), was an adjustable, floor-supported, vertical frame with a movable horizontal beam which supported a remotely controlled movable torch-mount assembly for cutting the cell liner walls. The WSD operating in the north test cell is shown in Figure 2.4.4.1. The second device, the floor segmentation device (FSD), used the same plasma-arc torch, mount, and power supply as the WSD; however, it had two-dimensional radial positioning capability rather than the three-dimensional linear positioning of the WSD. A floor-supported guide ring and a cogged radial extension arm provided the torch mount support and positioning structure for the FSD. The FSD is shown in Figure 2.4.4.2. Both devices were designed, fabricated, mockup-tested, and successfully utilized for removal of the vertical and horizontal portions of the test cell liner. These devices were successfully deployed to section the steel liner remotely and protect operating personnel from excess radiation exposure.

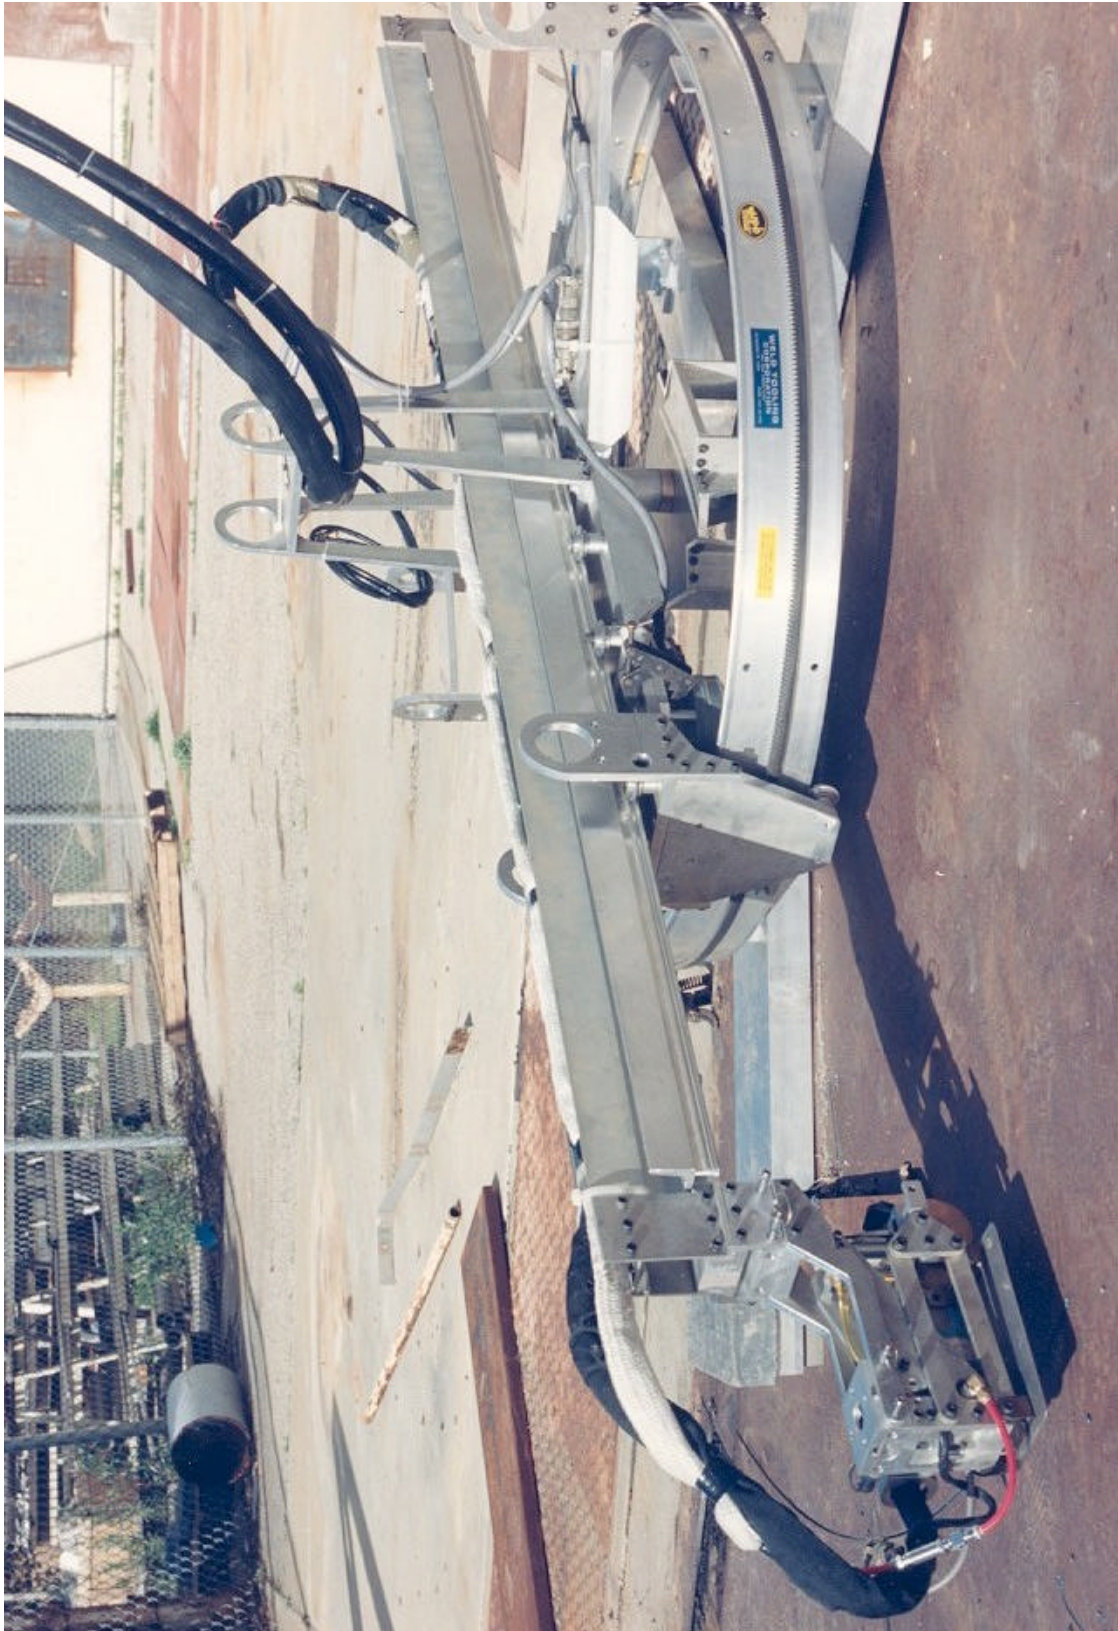
*Figure 2.4.4.2 North Test Cell Floor Liner Segmenting Device (FSD)*

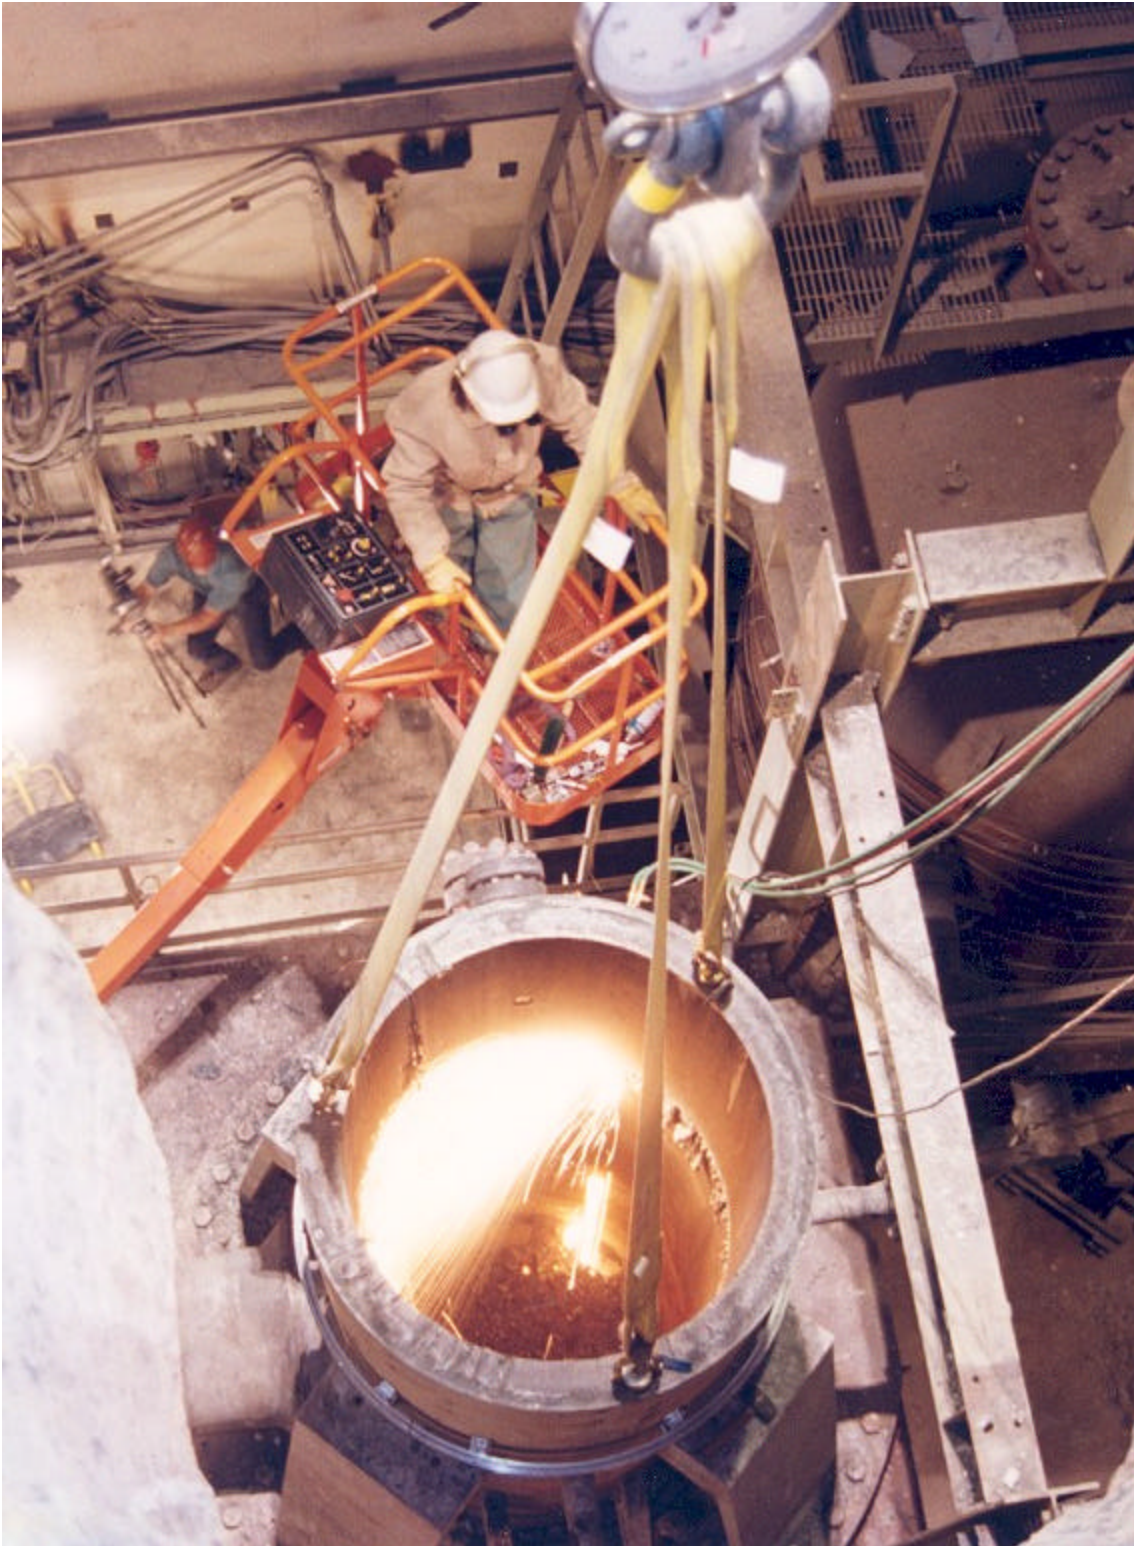
*Figure 2.5.3.3 LLTR System Vessel Removal to Allow Radiation Survey of Facility Surfaces*
